**Flood Control Project Maintenance****2011 Structure Summary Report****Overall Unit and Item Ratings****Merced Streams Group****Black Rascal Creek Drop Structure**

**Flood Control Project Maintenance****Unit Cover Sheet****2011 Structure Inspection Results****Merced Streams Group**

Structure
Black Rascal Creek Drop Structure

**Flood Control Project Maintenance  
Levee Inspections**

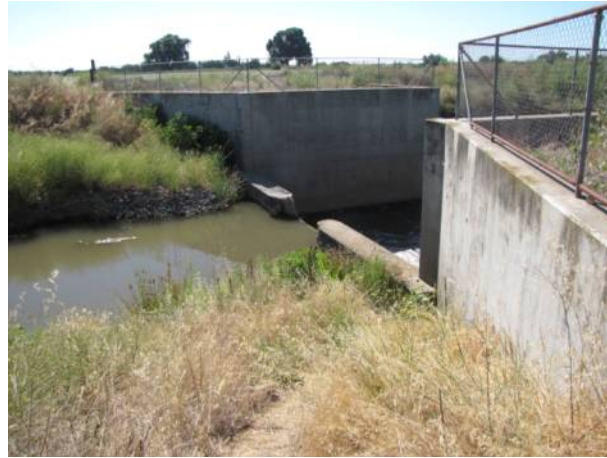
phillips\_t\_20110901\_002.jpg

Black Rascal Creek Drop Structure viewed from right bank unit 1(upstream end) looking across at unit 2 left bank. Photo taken 7-12-2011

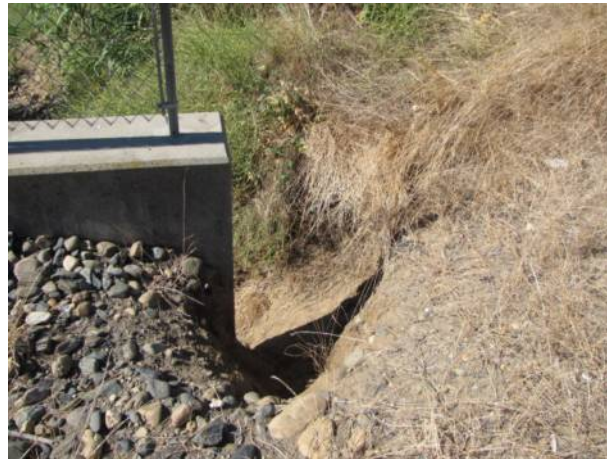
phillips\_t\_20110901\_003.jpg

Unit 1 downstream water ward slope erosion right at concrete headwall.37.31462 -120.39627. This erosion caused by pedestrian foot traffic.

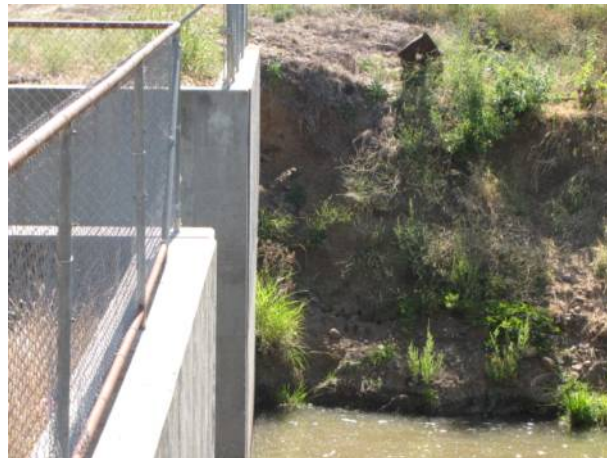
phillips\_t\_20110901\_004.jpg

Looking across channel at unit 2 downstream of structure there is bank erosion. Make repairs before it gets worse.

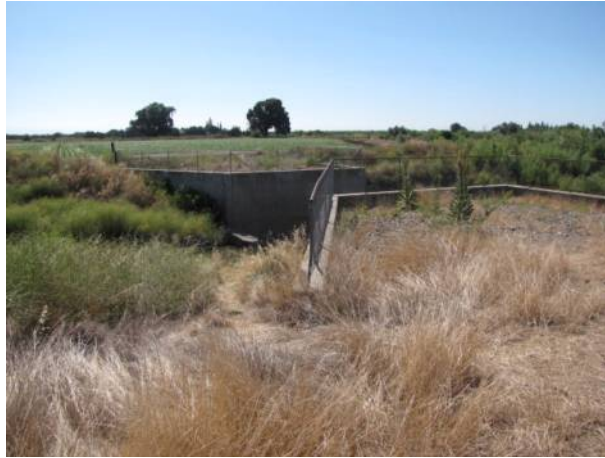
phillips\_t\_20110902\_006.jpg

This photo of Black Rascal Creek Drop Structure shows the safety fence right bank and left bank side of the structure. Photo taken 7-20-2011.

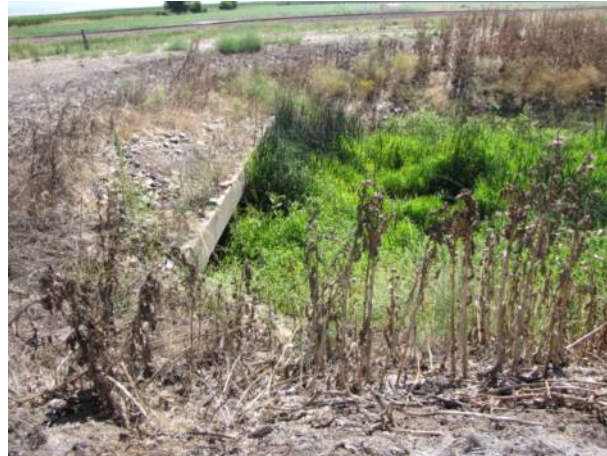
Levee Mile Report Line	1
Start Levee Mile	0.00
End Levee Mile	0.00
Location	
Category	Structures
Item	Photo Documentation
Owens Creek Siphon Structure outlet end. This photo was taken 7-12-2011. 37.262343 - 120.285349 L/M 0.39	
phillips_t_20110901_005.jpg

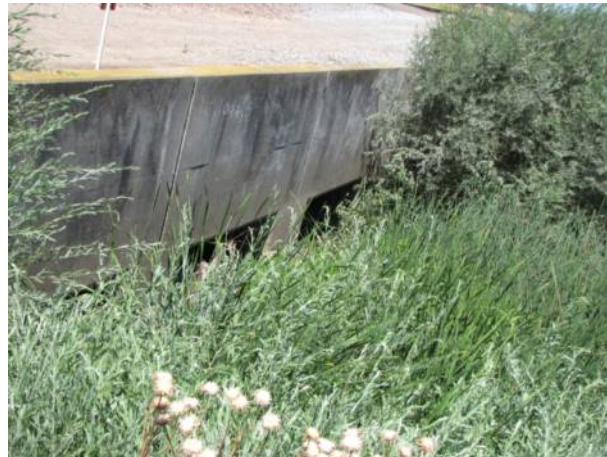
Levee Mile Report Line	1
Start Levee Mile	0.00
End Levee Mile	0.00
Location	
Category	Structures
Item	Photo Documentation
This photo here shows the inlet of the Owens Creek Siphon Structure. There is an over growth of Tullies and Willow trees growing in channel that need to be removed. Photo taken 7-12-2011. 37.26288 -120.28786 L/M 1.02	
phillips_t_20110902_009.jpg

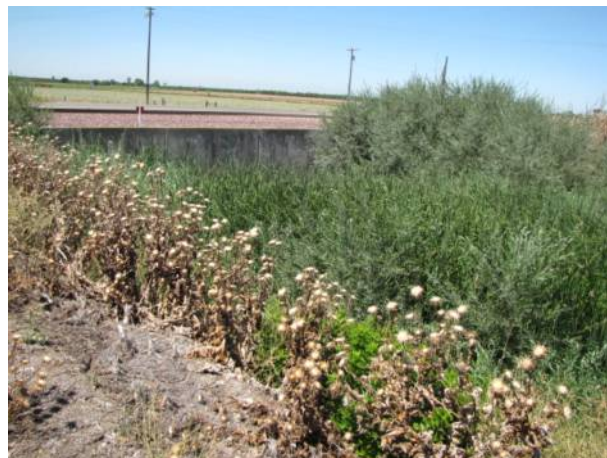
Levee Mile Report Line	2
Start Levee Mile	0.00
End Levee Mile	0.00
Location	
Category	Structures
Item	Vegetation & Obstructions
Wild growth of willow trees, tulies and other wild growth present in channel blocking inlet. Wild growth needs to be removed. Unable to see if other issues exist due to vegetation.	
phillips_t_20110902_011.jpg
